Recent experience and issues with embankment dams

- Sinthe Dam Myanmar
- La Ferme Dam Mauritius
-

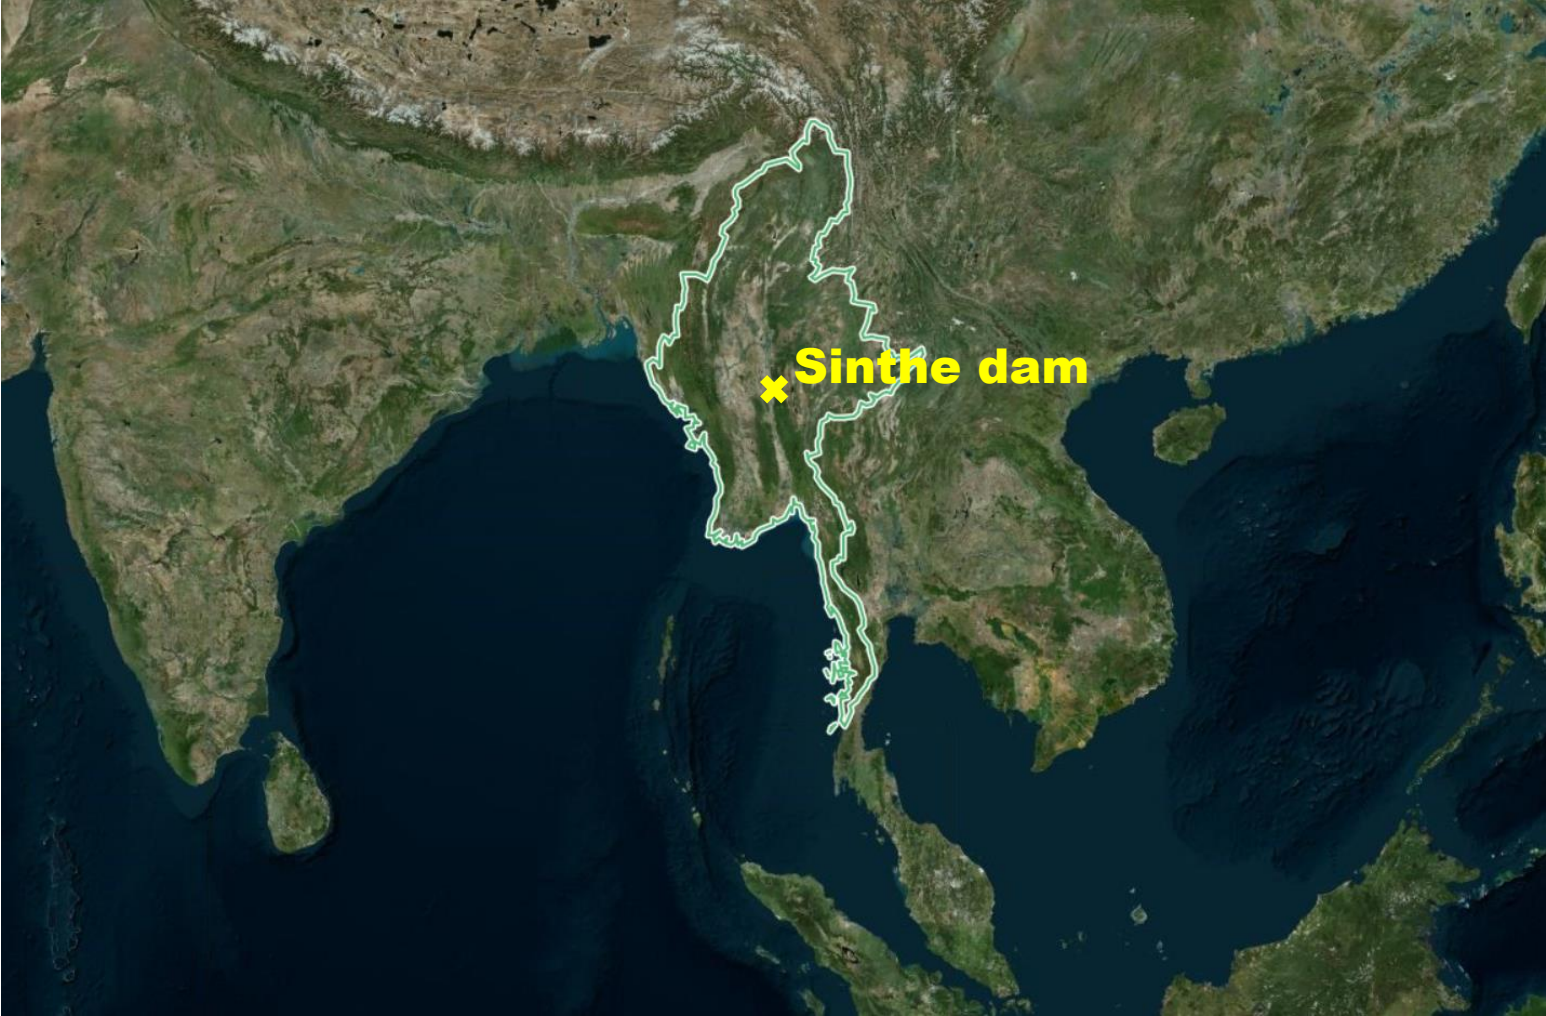
Sinthe Dam in Myanmar

- Dam located in the Nay Pyi Taw Region
- Completed in 2000 for irrigation water supply
- Embankment dam of homogeneous earthfill
- Chimney filter to control seepage
- 33m high
- Crest length of 1350m

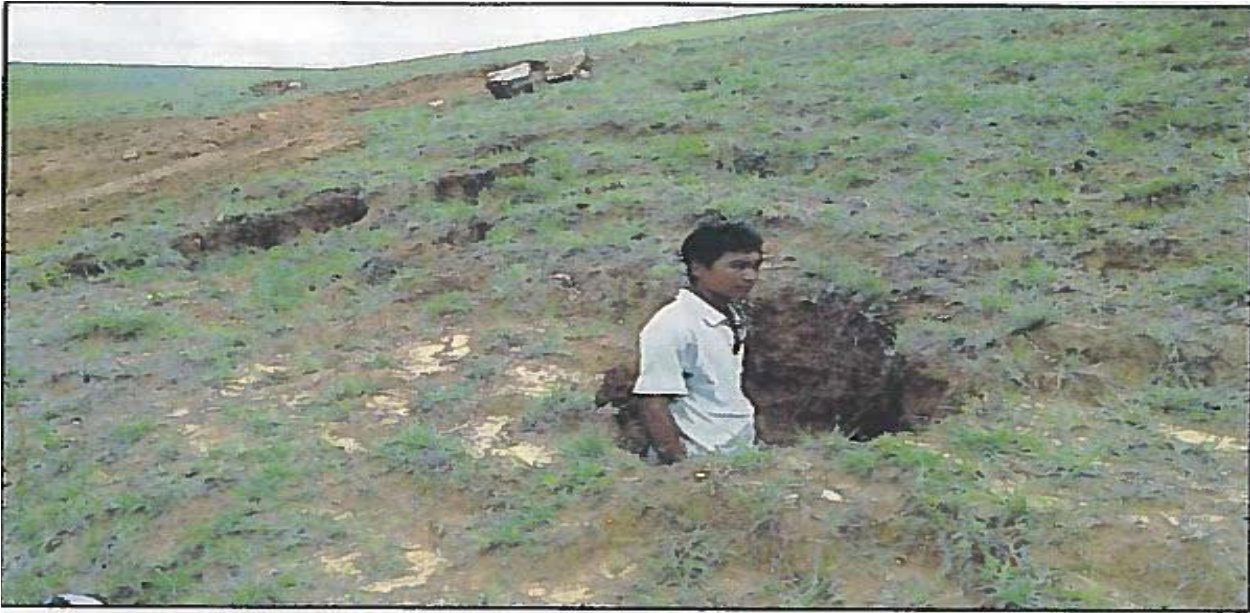
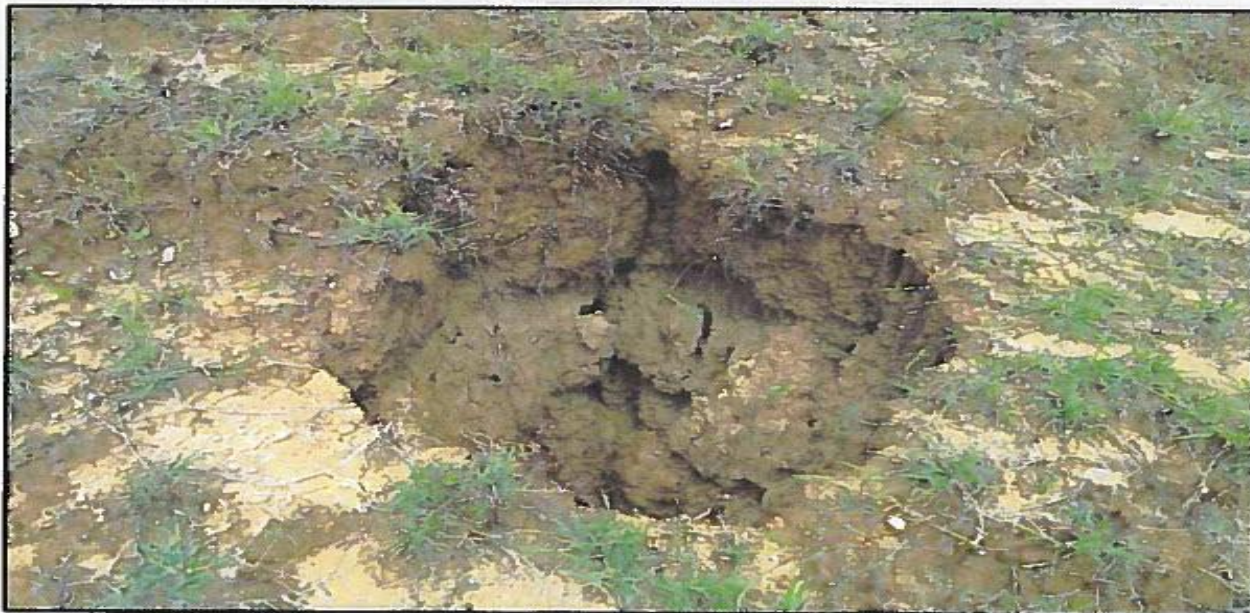
Construction material dispersivity

- Crumb tests during construction:
 - ECN Class 5 to 6 obtained (mid scale)
 - some results as low as 1 and 2 (very dispersive).
- Sherard and Decker (1977) suggest four tests should be used:

Soil Conservation Service, Pinhole, Emerson, Chemical test.
- They were of the opinion that the pinhole test was best.

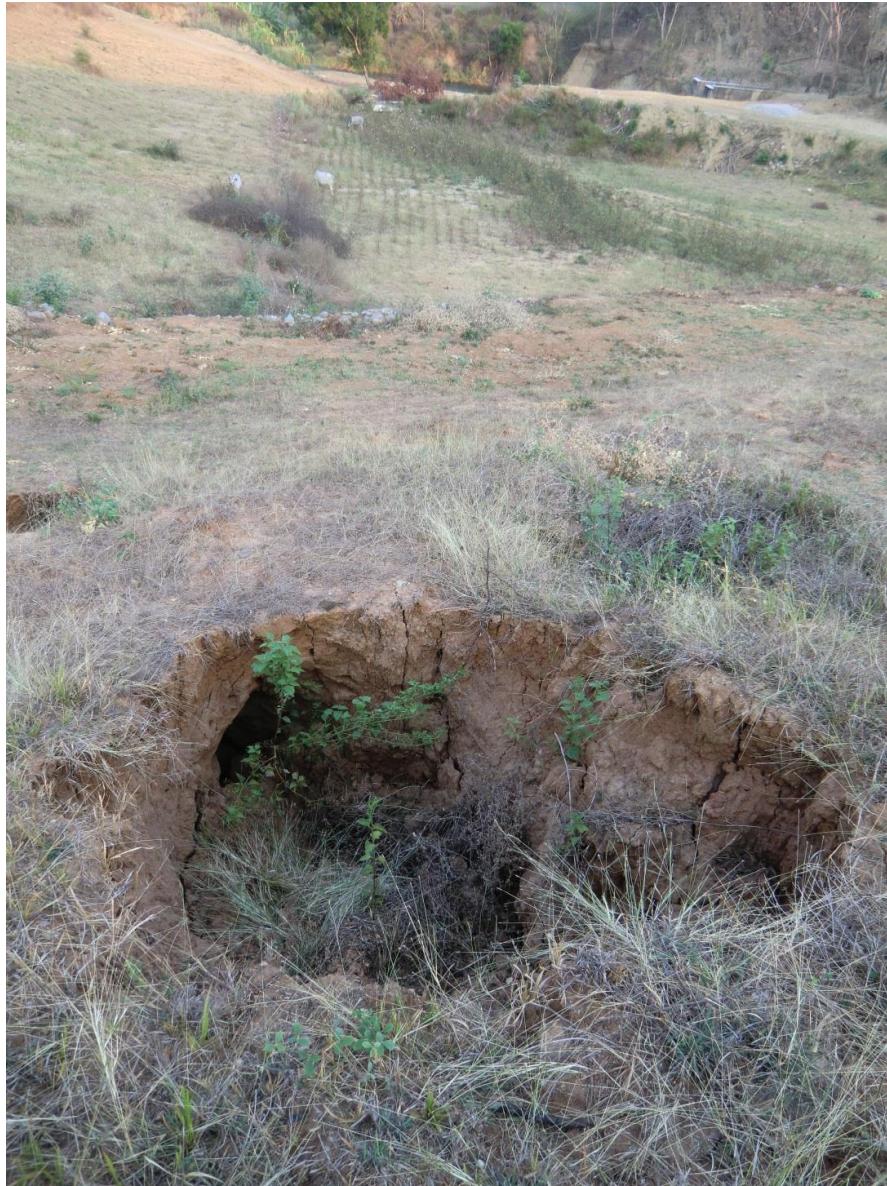
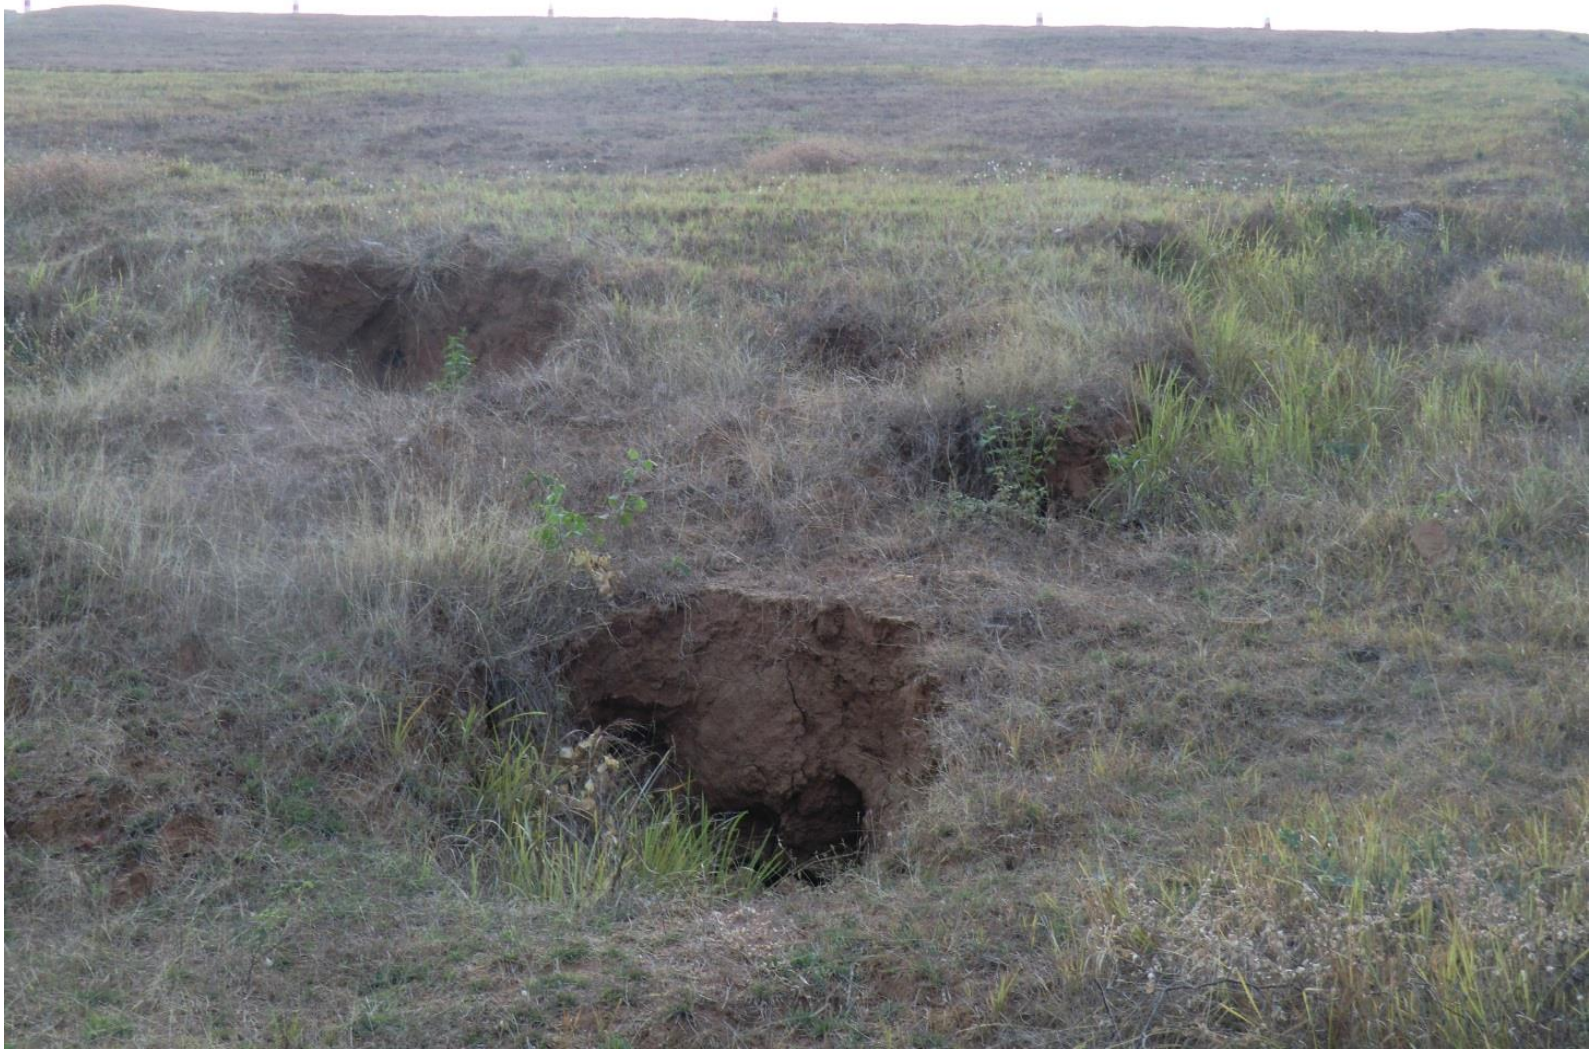
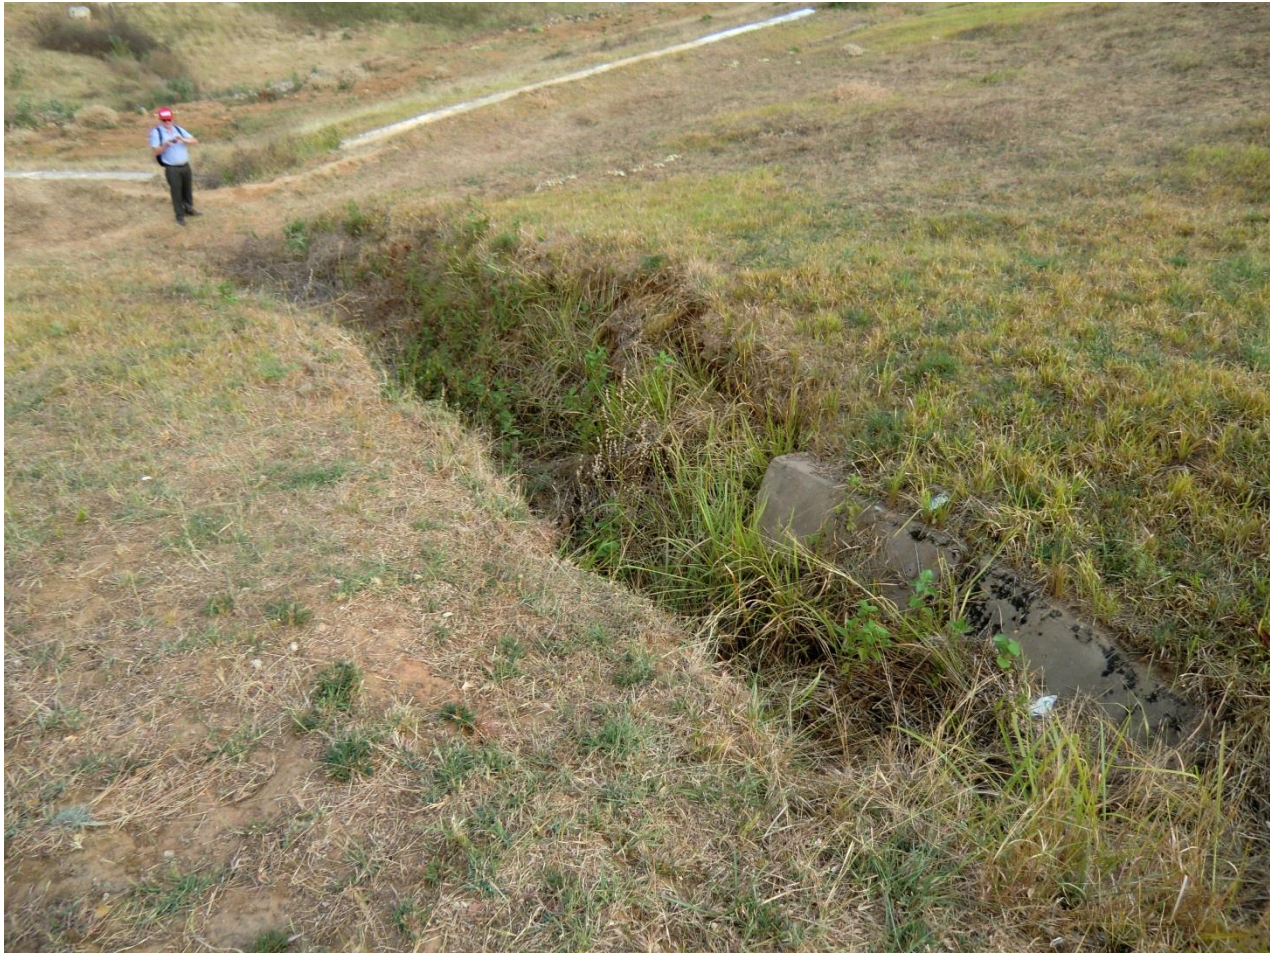
- Dispersive soils within the embankment fill susceptible to erosion
- Severe surface erosion gully, internal erosion / piping / sinkholes
- Drainage collecting gutter and chute heavily under designed
- Sloughing, bulging, uneven settlement

- Backfilling of sinkholes
- Repair of drainage channels

- Map the areas that show high erosion, sample and test for dispersivity by performing the Pinhole Test
- Undertake seepage and stability analysis for higher permeability in the fill and foundations
- Check adequacy of the surface drainage channels to collect and discharge the surface run-off

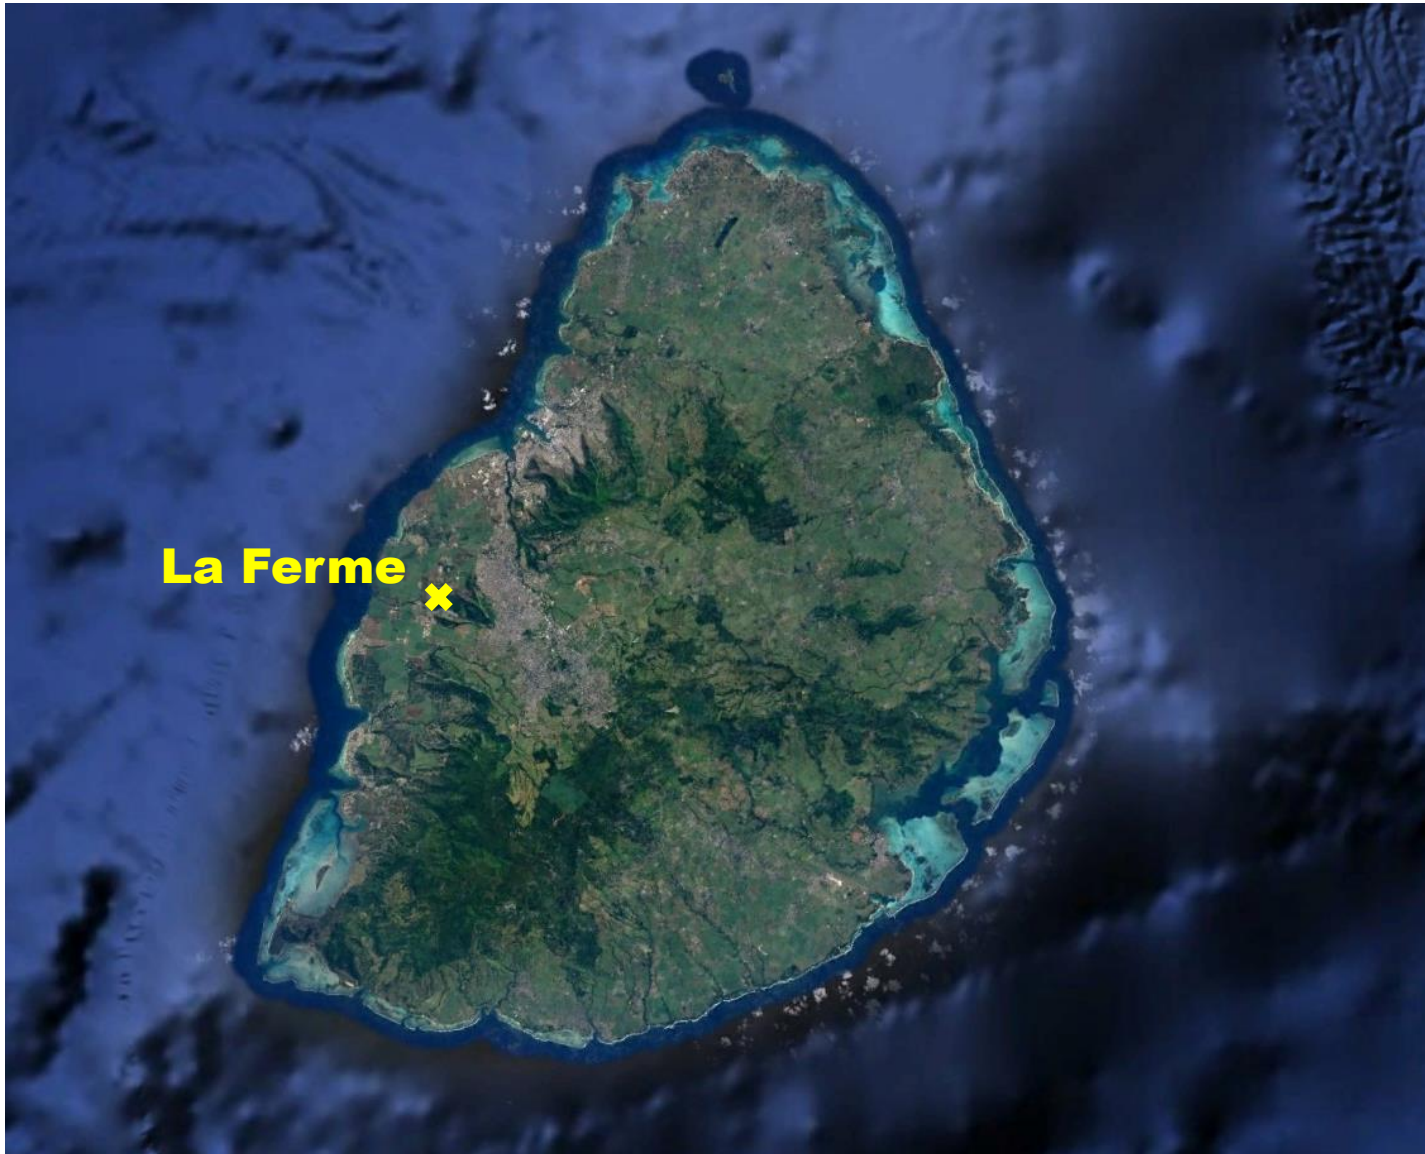
La Ferme Dam, Mauritius

- Constructed in 1914 to store water for irrigation purposes
- Combined gravity and embankment dam
- Max height 15m, 1500m long
- Rehabilitated to improve its safety to extreme flood and raise the dam to increase the storage capacity
